Assessment Report

Margaret Creek Watershed Margaret Creek 6, Fox Lake Athens County, Ohio

Prepared by: Natural Resources Conservation Service
Columbus, Ohio
September 2009

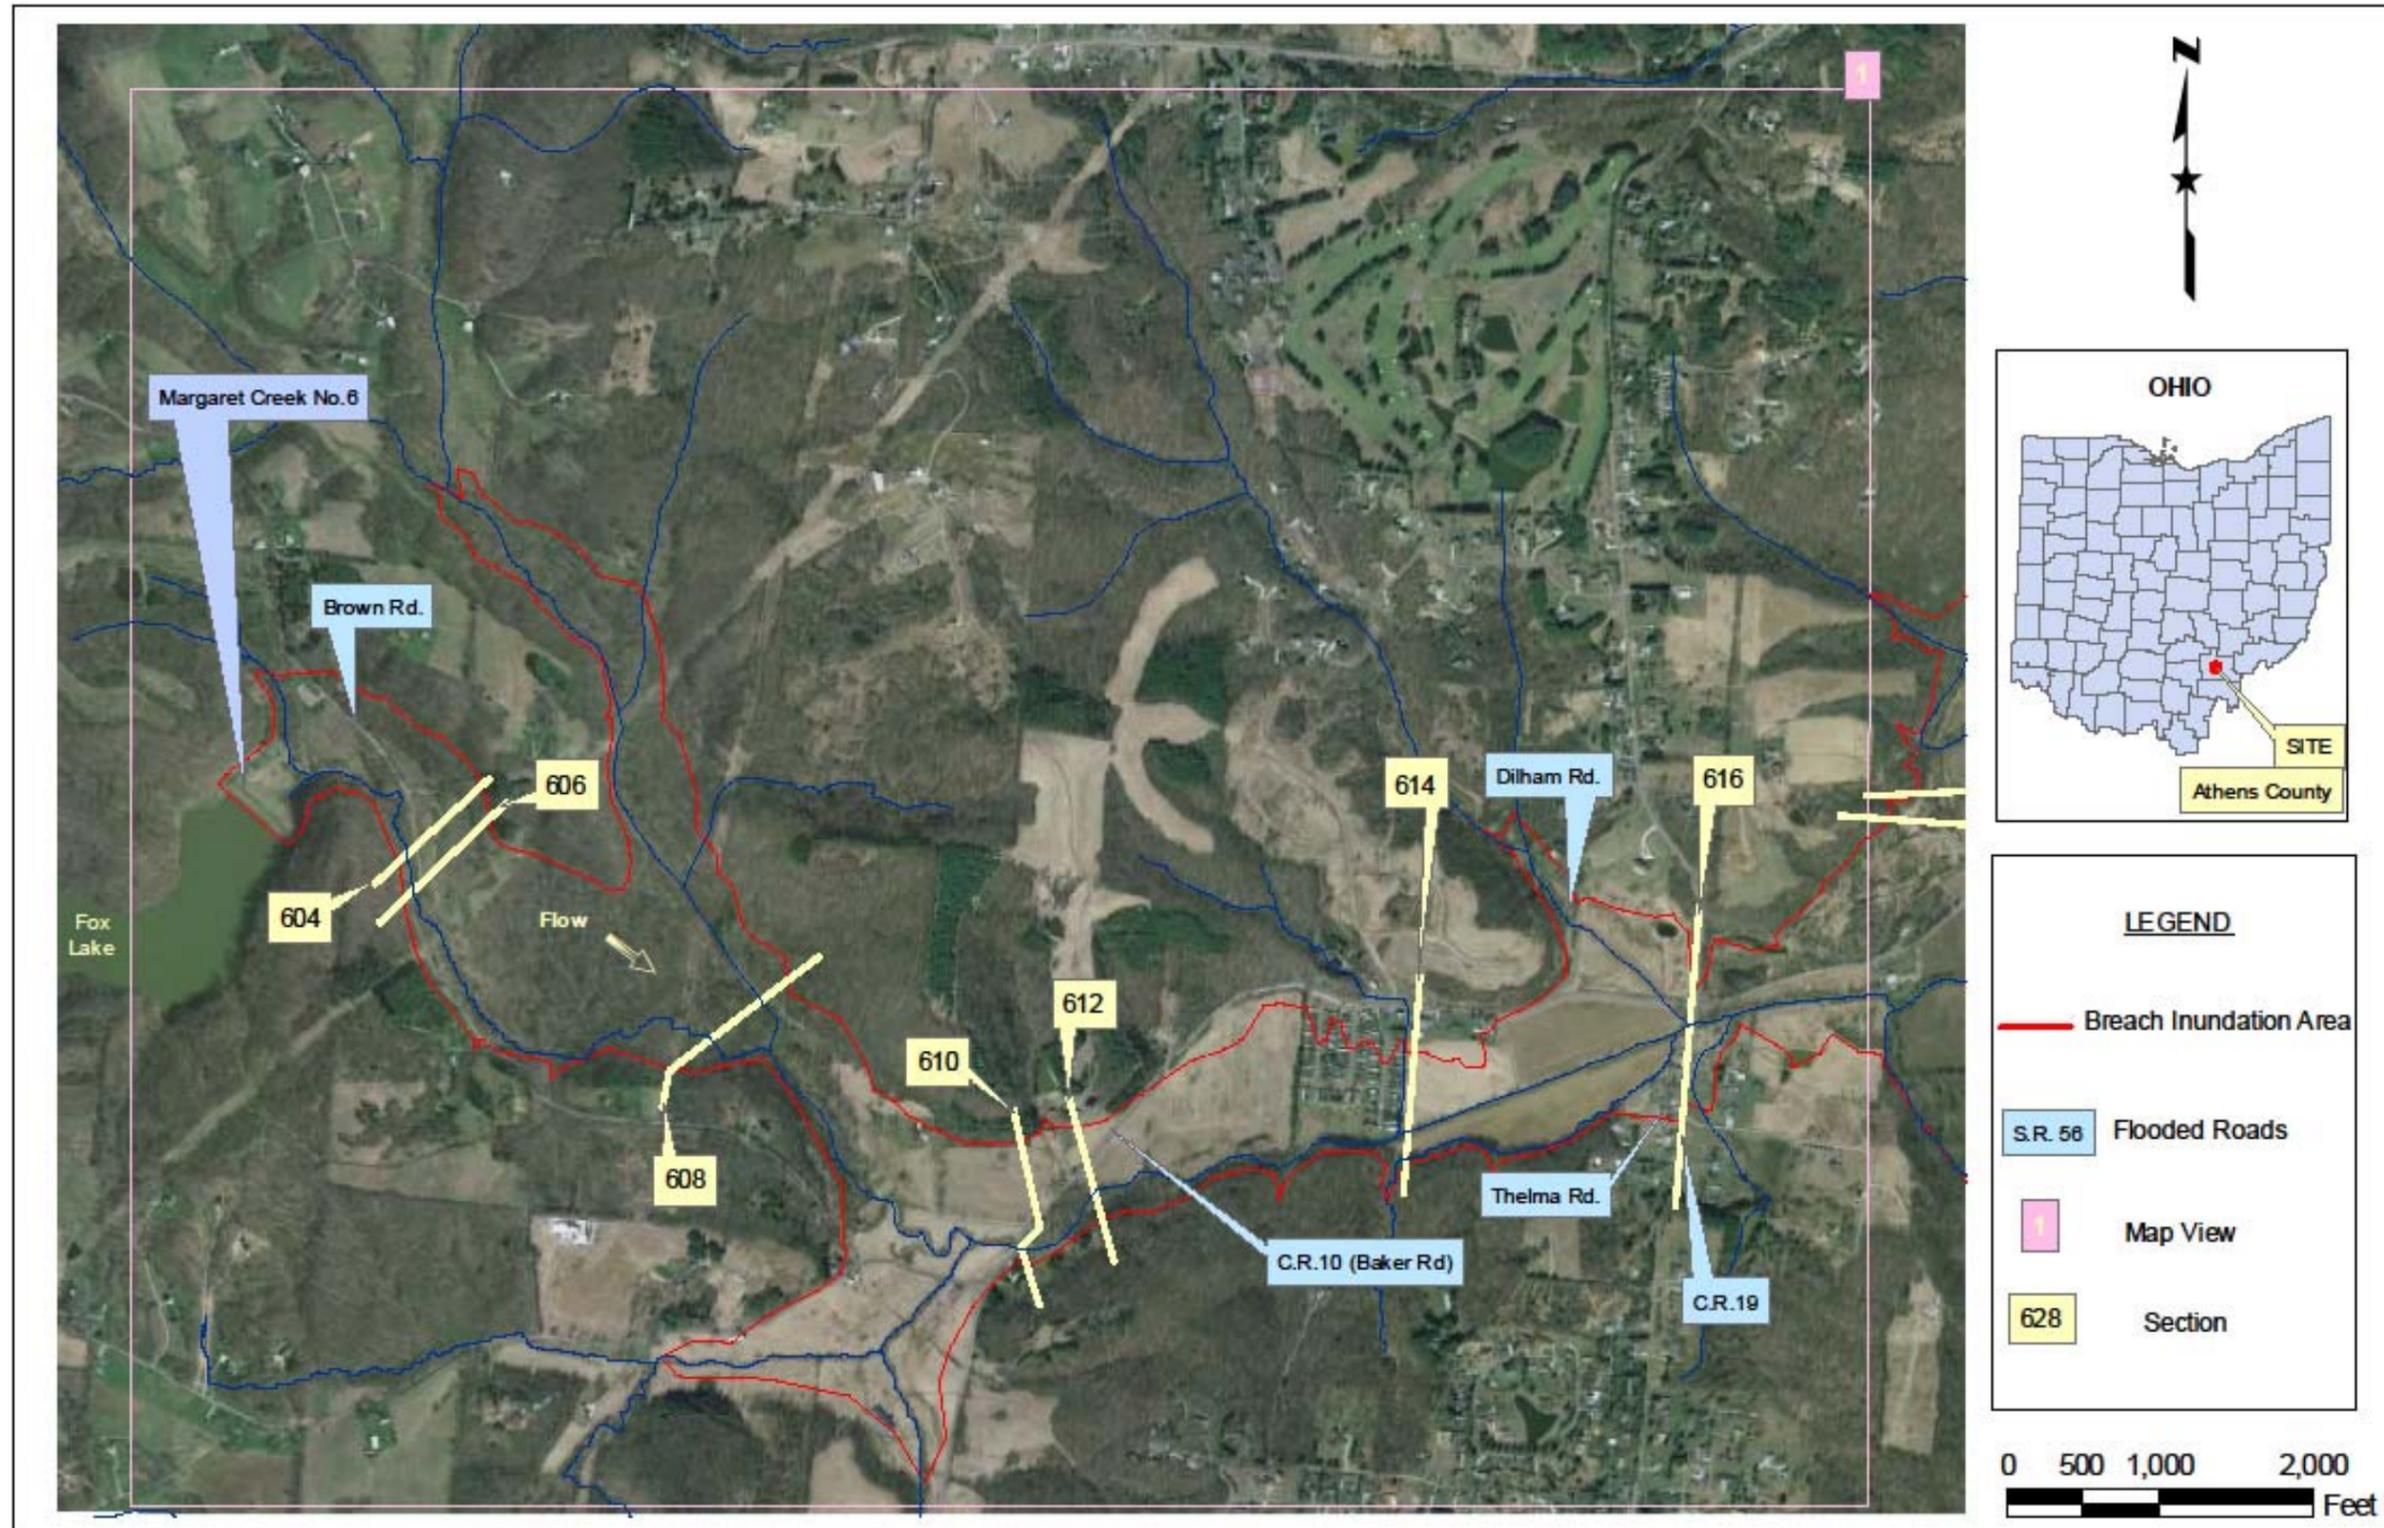
MAP 1
Athens County, Ohio 809

The results of the breach analysis are shown on the dam breach inundation maps (attached). Based on the latest available ortho imagery (2007), there are 5 bridges, 10 unclassified structures (homes, businesses, outbuildings), and 40+ house trailers within the breach inundation area. There is the potential for loss of life in the event of a dam failure.
